**SUBJECT:** Historic Structures Survey Report, Construct Roundabout at SR 3136 (Cane Creek Road) and SR 3116 (Mills Gap Road), PA 21-07-0005, Buncombe County, ER 21-3260

Historic Structure Report  
Construct Roundabout at SR 3136 (Cane Creek Road) and  
SR 3116 (Mills Gap Road)  
WBS No. 48915.1.1, PA No. 21-07-0005  
Buncombe County, North Carolina  
S&ME Project No. 218293

### 2.1 Meadow’s Store and Apartments (BN6343)

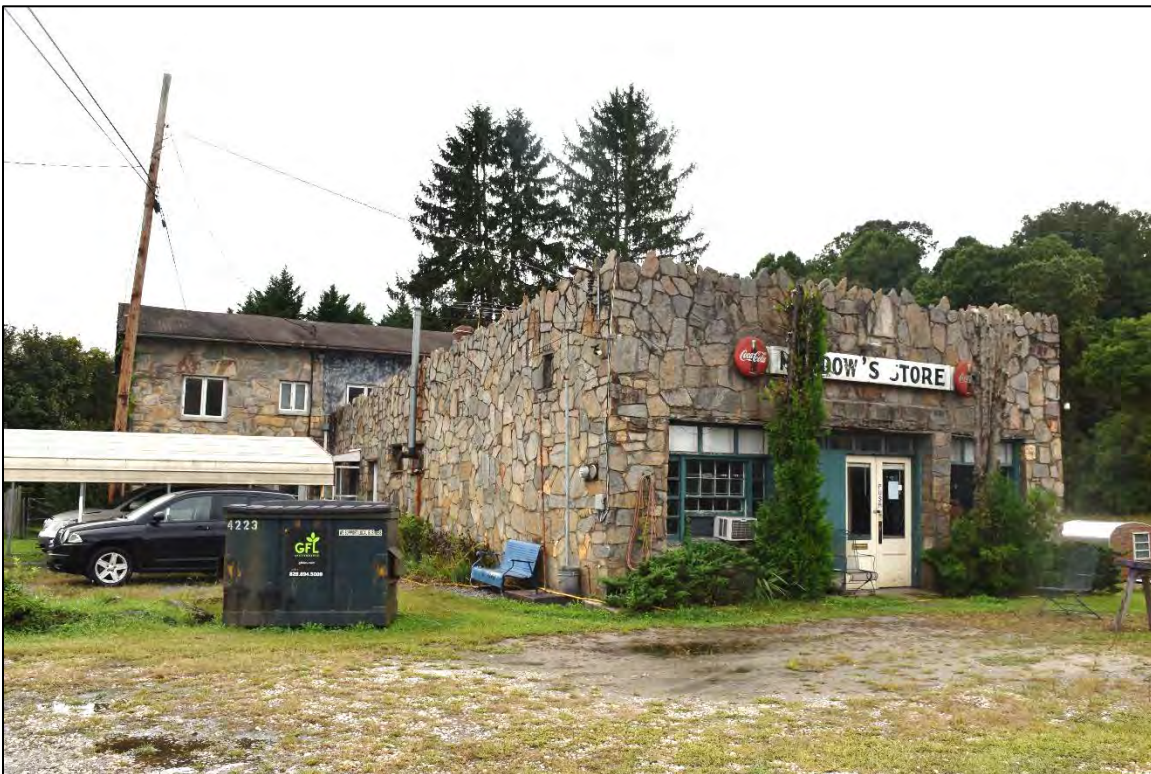
**Figure 2.1. Meadow’s Store and Apartments (BN6343), facing southwest.**

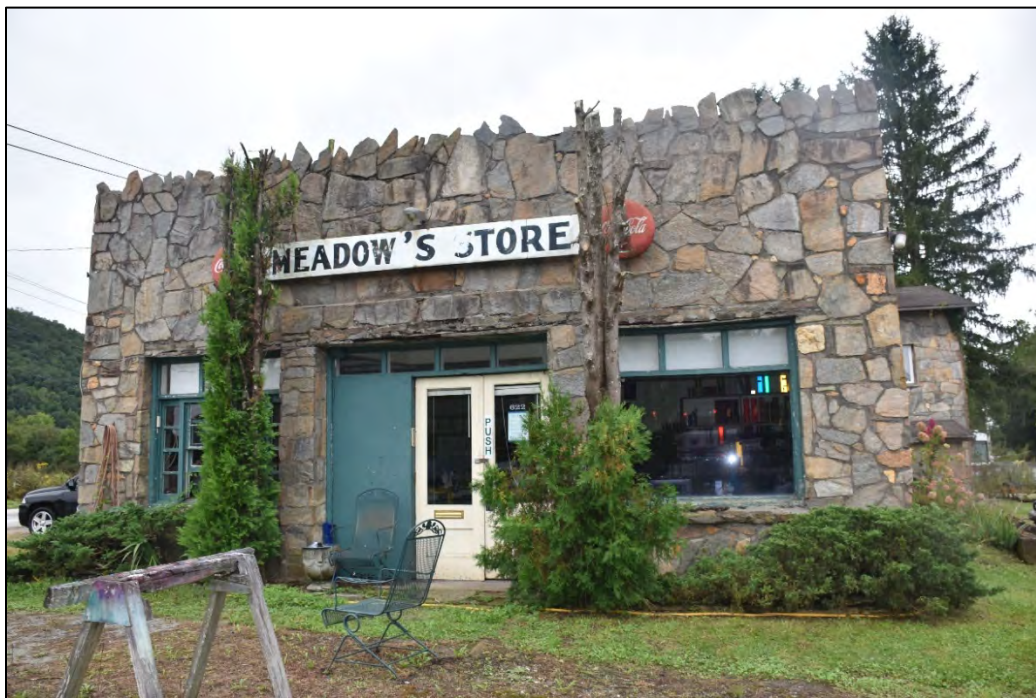
The commercial section of the building is one-story, with a flat roof and is oriented with its front elevation facing north, toward the intersection of Cane Creek and Mills Gap roads. The structure is concrete block masonry with a fieldstone veneer, which extends in a rough edge above the roofline to create a small parapet wall (Figure 2.3). The north elevation has a large central entryway, which is surrounded by a slightly protruding stone surround. The entryway currently has a double wooden entry door, with each door having a large single-pane window above a single lower panel, on the western side of the entryway; the eastern side has been enclosed with a metal panel (Figure 2.4). Above the doors and metal panel is a four-pane, wooden-framed transom. The entryway is flanked by a display window in either side, each with a protruding stone sill. The western window is original to the retail building and has a single-pane display window with a three-pane transom above, each encased within a wooden frame (Figure 2.5). The window to the east retains its original three-pane transom, but the lower window has been replaced with an eight-over-eight, double-hung, wooden sash flanked by a four-pane sidelight on either side (Figure 2.6). A sign reading "Meadow's Store", flanked by two round "Coca-Cola" signs, is mounted above the doorway.

Figure 2.3. Meadow's Store and Apartments (BN6343), facing south.

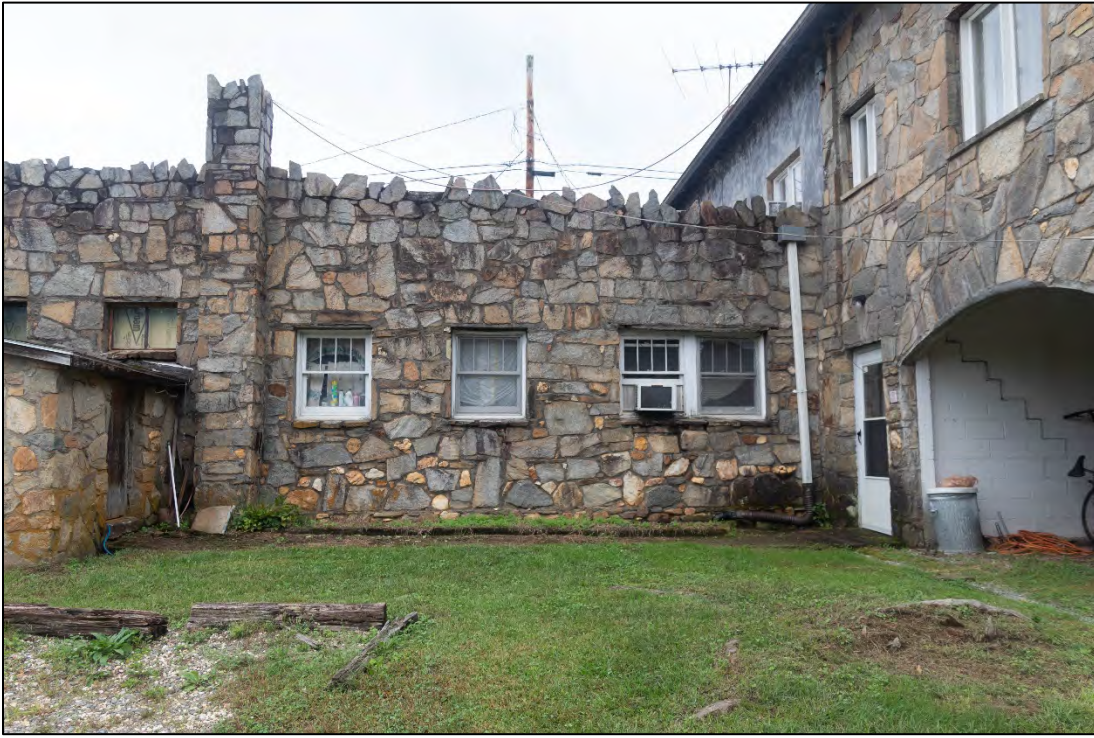
The east elevation of the one-story portion of the structure has an entry door, which is a wooden door with three lower panels and six upper panes, located beneath a metal awning (Figure 2.7). To the north of the door is a single four-over-one, double-hung, wooden sash window and to the south is a paired four-over-one, double-hung, wooden sash window. This entryway and windows are part of a small living area located behind the store. North of the side entry door, there are two, small window openings, each with a two-pane, metal frame window (Figure 2.8). The north elevation on the one-story portion of the building also has two, small window openings, each with a two-pane, metal frame window (Figure 2.9). Below these windows is a small side-gabled addition with a small entry door on its south wall; south of the addition, there is an exterior chimney with stone veneer. To the south of the chimney, corresponding to the rear living area behind the retail space, there are two single and one paired four-over-four, double-hung, wooden sash windows (Figure 2.10).

**Figure 2.10. Meadow's Store and Apartments (BN6343), facing east.**

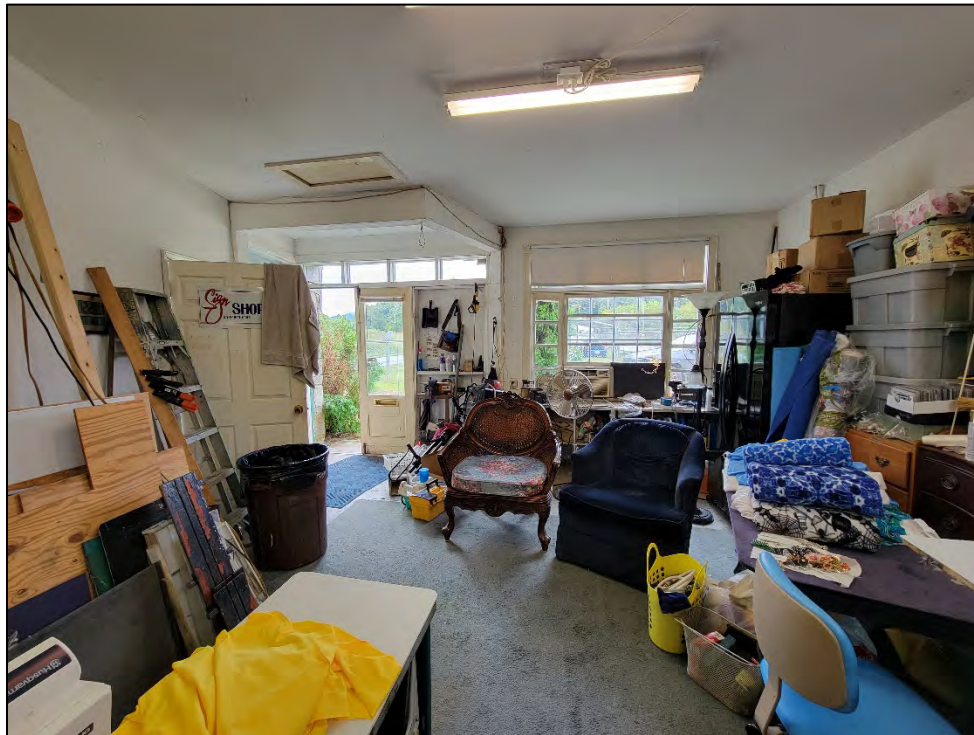
The interior of the retail portion of the Meadow's Store and Apartments building has a large open space, with some original plaster interior walls and a modern vinyl tile floor (Figures 2.11 and 2.12). The western portion of the interior has been enclosed to create an office. The vestiges of the original recessed entryway and canted display windows remains behind the current entryway. The western portion of the original entryway remains, creating a portion of the wall for the office, with a large, single-pane, wooden-framed display window (Figure 2.13). The eastern portion of the original entryway, as well as the recessed door portion between the two canted sections, has been removed, although the framing along the ceiling remains (Figure 2.14). No display cases or fixtures from the building's period as a dry goods store remain. A metal wood-burning stove is located in the rear corner of the building with the exhaust piped through one of the two-pane, metal windows on the east elevation (Figure 2.15). Behind the office, the rear of the western portion of the retail space has also been enclosed, as has the rear portion of the eastern side of the store, with a wall running between the two metal-frame windows (Figures 2.16–2.18). The interior of the former retail space is currently used mostly for storage, although it housed a sign-making business until 2020. Access to the interior of the rear living space was not granted.

**Figure 2.11. Meadow's Store and Apartments (BN6343), store interior, facing north.**

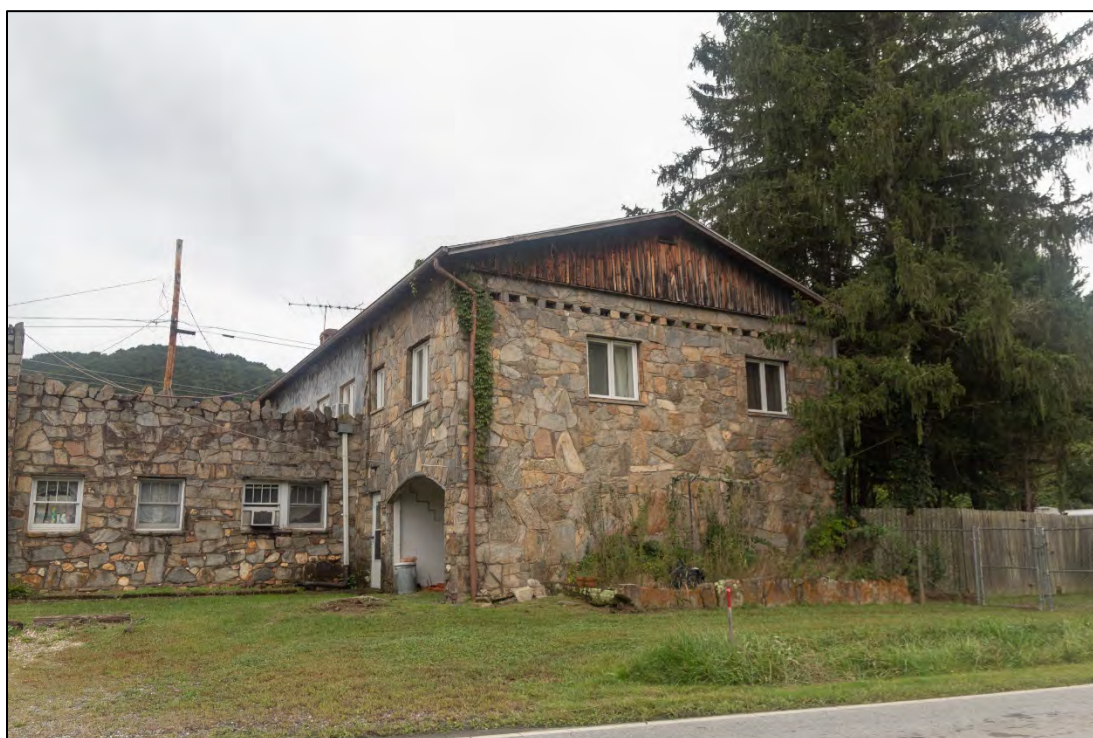
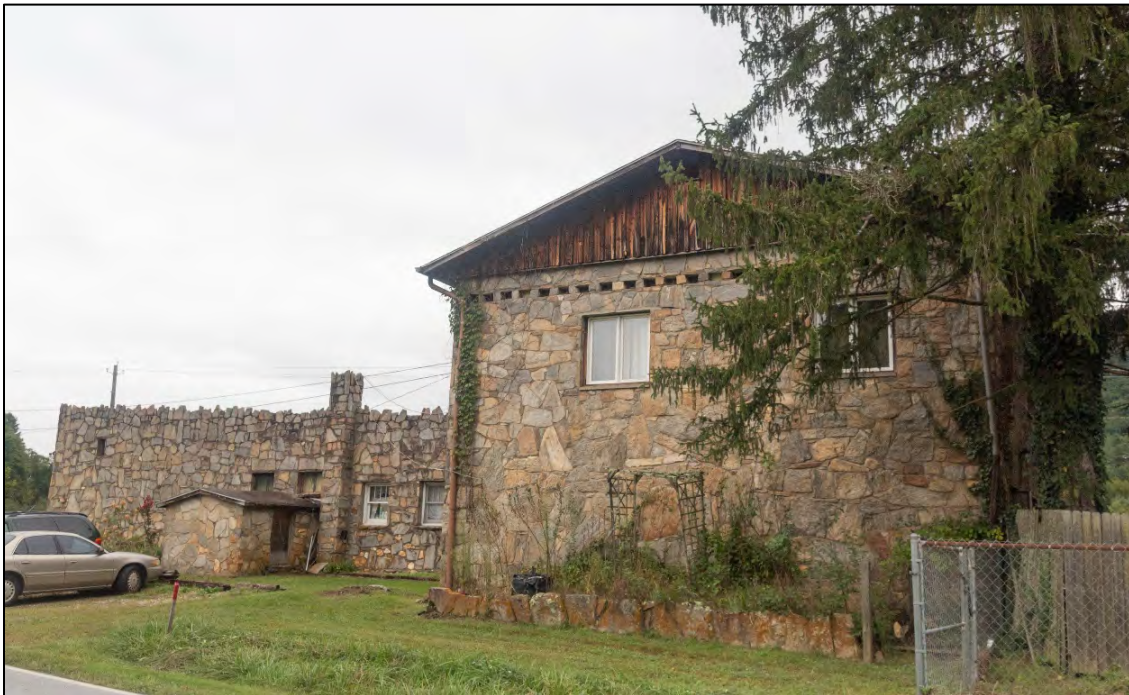
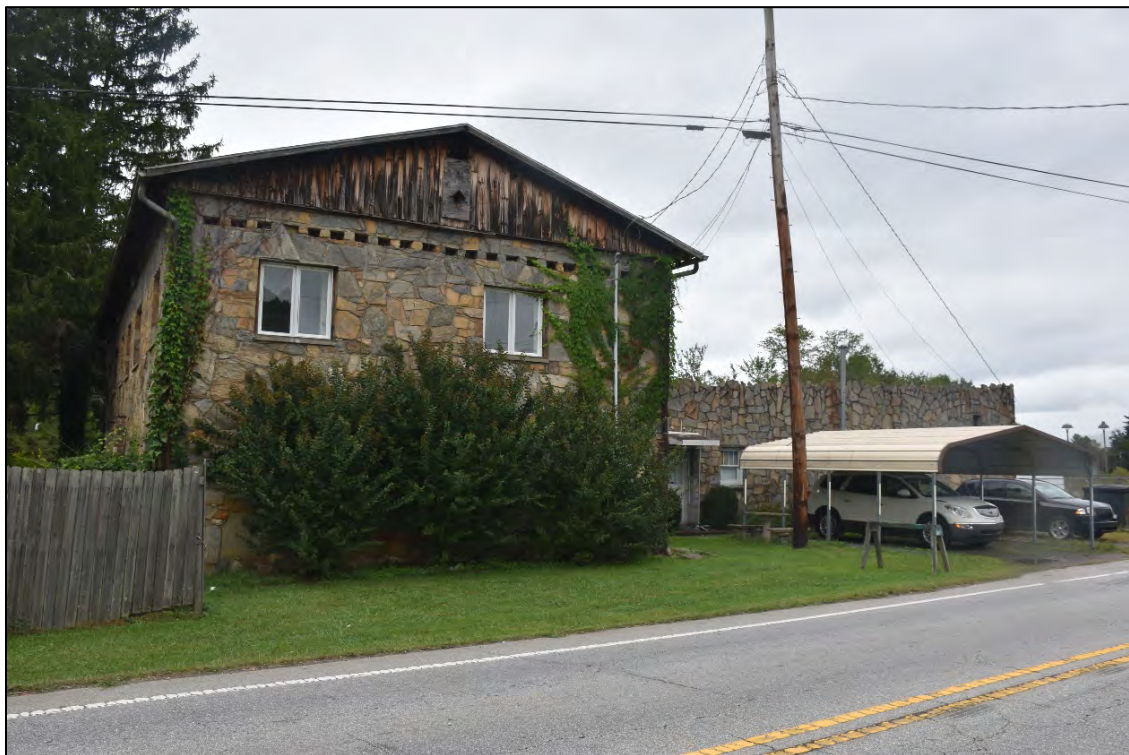
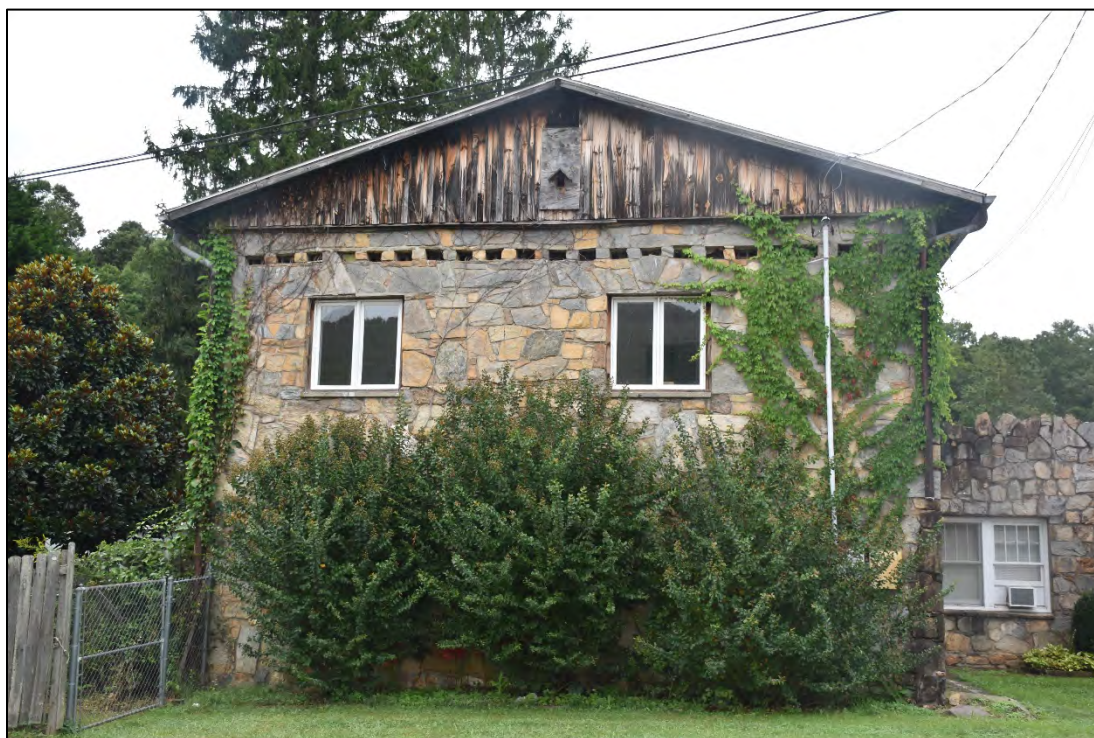
Attached to the south elevation of the one-story, flat-roofed retail portion of the building is a two-story, side-gabled apartment building that was added in the mid-1950s and extends past the east and west elevations of the earlier retail portion of the resource. Originally a flat-roofed building, the gabled roof was added in the 1980s. The two-story, residential section of the building is symmetrical, with five bays on the south elevation, two bays both the east and west elevations, and eight bays across the north elevation. On the north elevation, there are four bays located above the intersecting rear wall of the one-story commercial portion, each with a two-pane, vinyl frame window; on the portion of the second-story wall above the one-story section, the stone has been removed and the wall has been painted (Figure 2.19). To the east and west of the one-story portion, each side of the north elevation has an entry door, with storm door, and an arched garage bay on the first story and two two-pane, vinyl frame windows, one smaller than the other, on the second story (Figures 2.20–2.22). On both the east and west elevations of the two-story section, there are two two-pane, vinyl frame windows on the second story and vertical wooden siding in the gable end, above a decorative line of small openings between the stone, which create an attic-level vent (Figures 2.23–2.26).

**Figure 2.23. Meadow's Store and Apartments (BN6343), facing southeast.**

**Figure 2.24 Meadow's Store and Apartments (BN6343), facing northeast.**

**Figure 2.25. Meadow's Store and Apartments (BN6343), facing northwest.**

**Figure 2.26. Meadow's Store and Apartments (BN6343), facing west.**

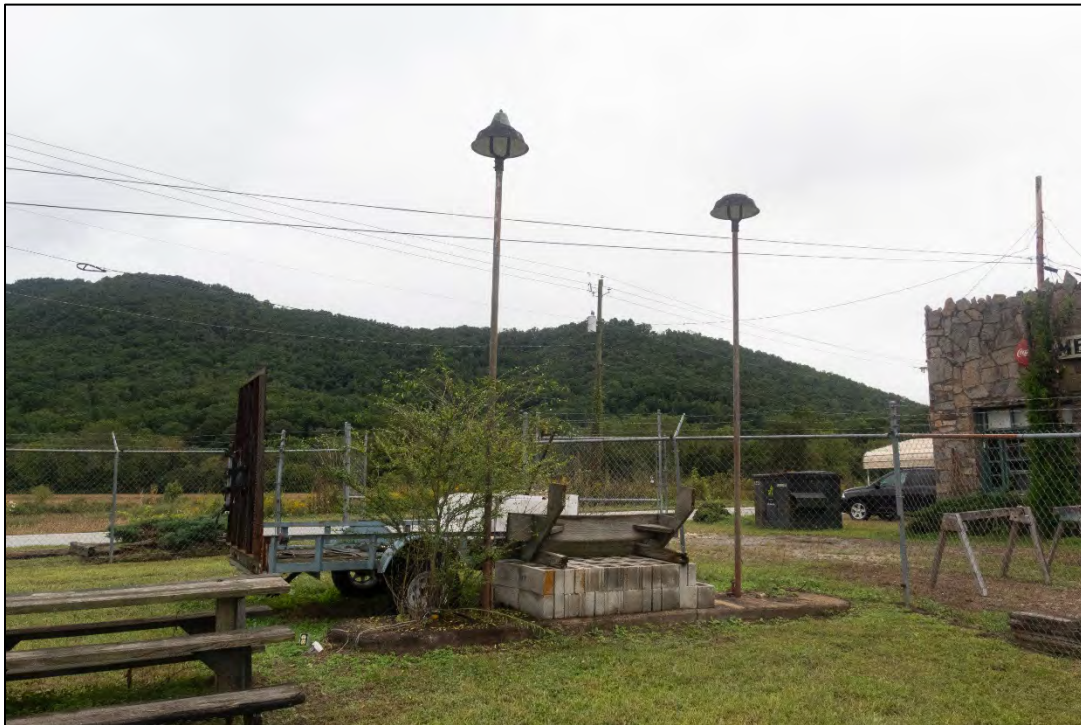
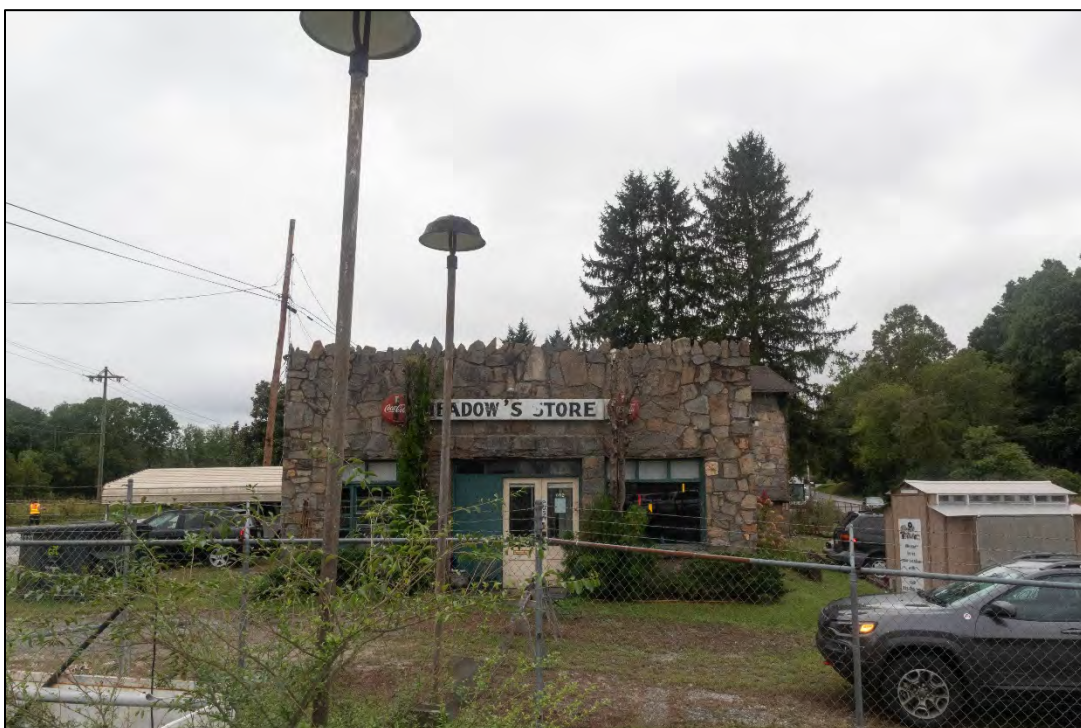
North of the Meadow's Store and Apartments building is the remains of a circa 1950s fuel island, from the period of significant growth in automobile traffic, when the Meadow's Store sold gasoline. Although the gas pumps themselves are no longer in place, the oblong raised concrete island and two metal lampposts are still visible within an area enclosed with a modern, chain-link fence (Figures 2.31 and 2.32).

**Figure 2.31. Meadow's Store and Apartments (BN6343), gas pump pavilion, facing east.**

**Figure 2.32. Meadow's Store and Apartments (BN6343), gas pump pavilion and storefront, facing south.**

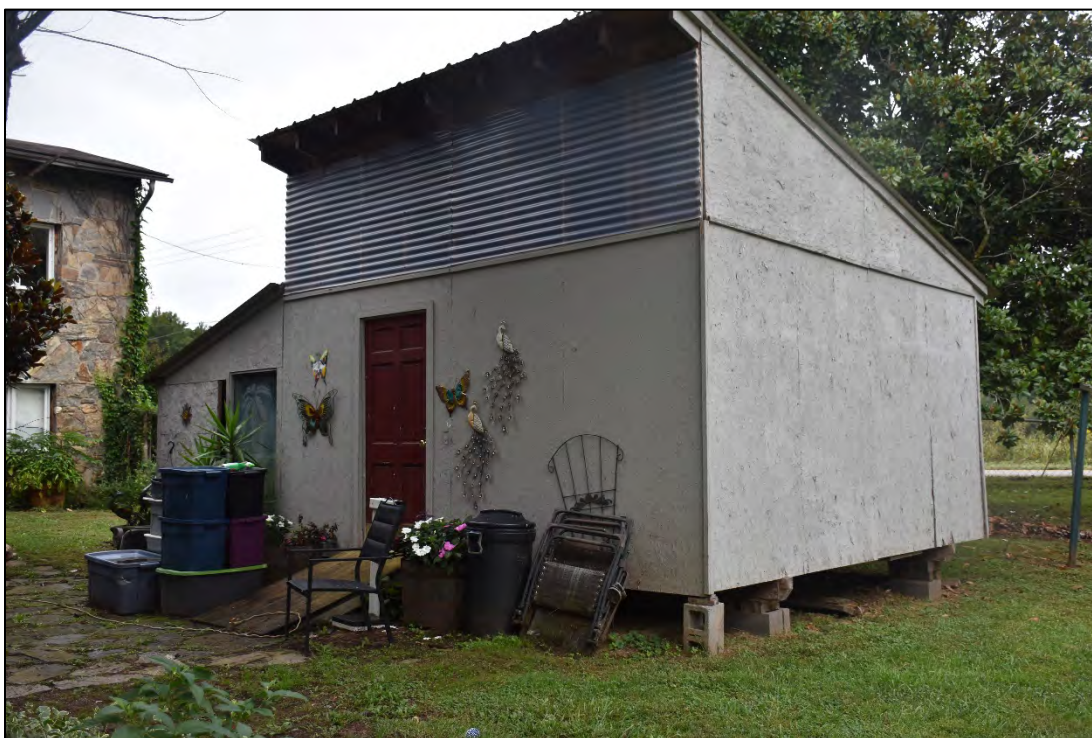
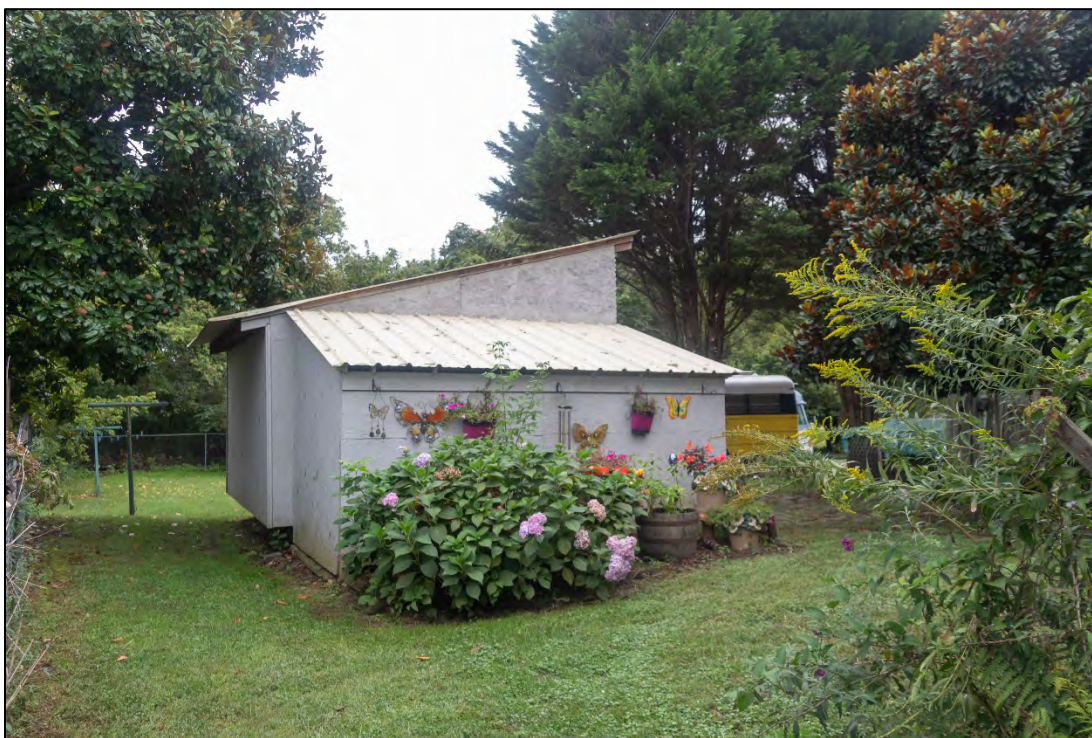
South of the Meadow's Store and Apartments building is a modern, wooden-framed shed (Figures 2.33 and 2.34). The shed, which rests on concrete block piers, has a larger section with a pent roof, that slopes down away from its west elevation, and a smaller, shed-roofed section attached to its north elevation. The larger portion has a single entry door, reached by a simple plywood ramp, on the west elevation; the walls are covered with painted plywood on the lower portion and corrugated metal on the upper portion. The smaller section to the north also has a single entry door and plywood-covered walls. The roof, which is covered with standing-seam metal, has visible raftertails.

**Figure 2.33. Meadow's Store and Apartments (BN6343), shed, facing northeast.**

**Figure 2.34. Meadow's Store and Apartments (BN6343), shed, facing south.**

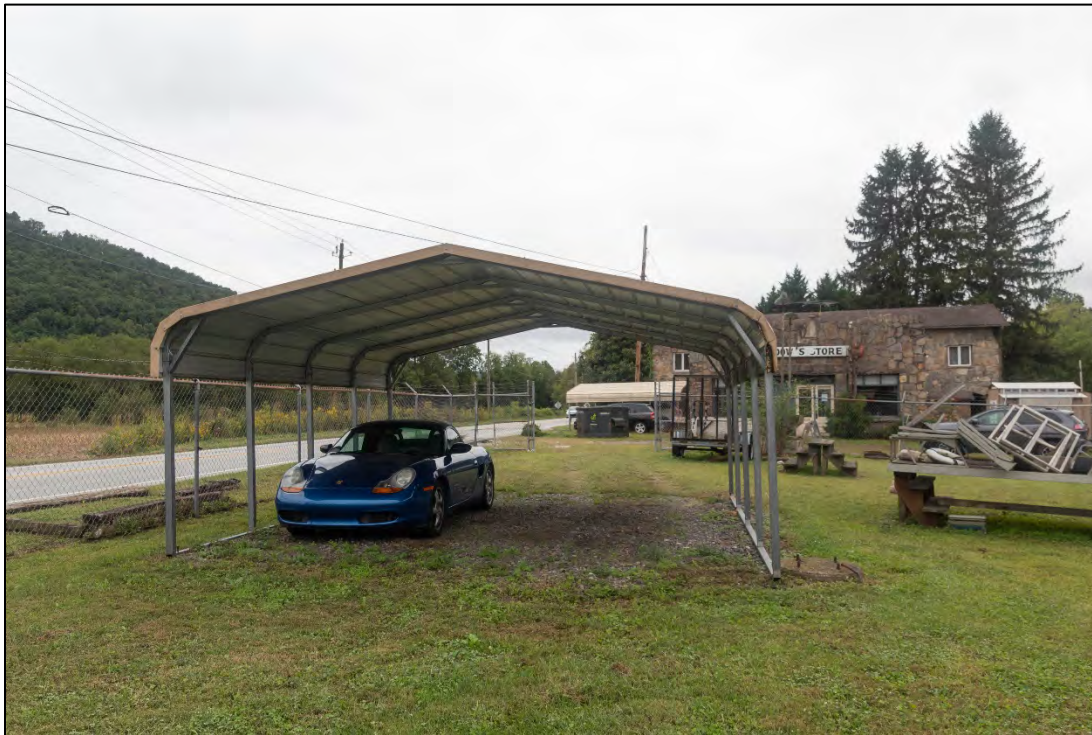
There are also two free-standing metal carport structures located on the property, to the north and to the east of the Meadow's Store and Apartments building (Figures 2.25 and 2.35).

**Figure 2.35. Meadow's Store and Apartments (BN6343), metal carport, facing south.**

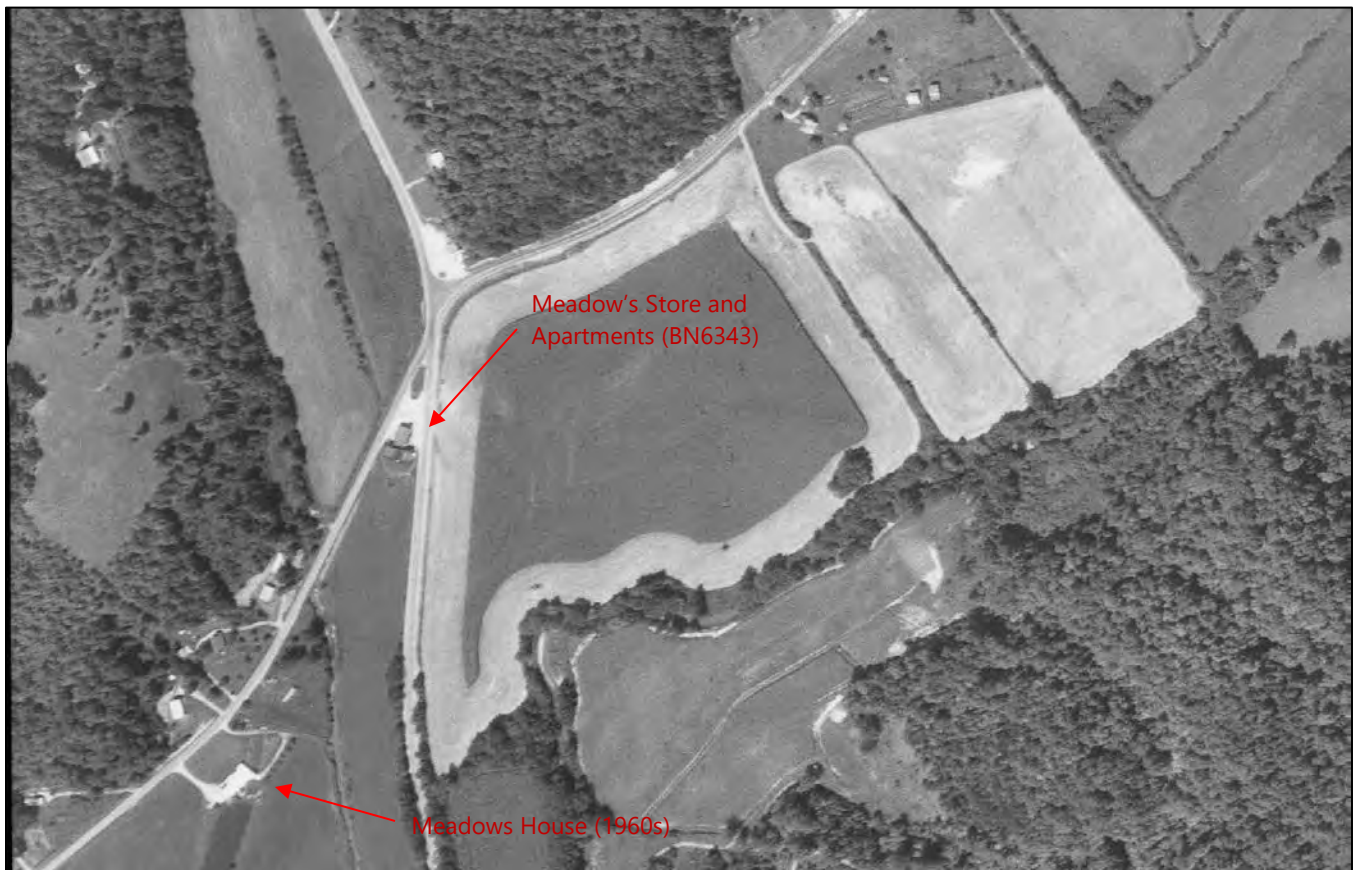
In 1955, Meadows constructed the two-story rear portion of the building as apartments; the building holds two six-room apartment homes, each with an open garage parking bay (Figures 2.42 and 2.43). Once this building was complete, the Meadows family moved into one of the apartments and rented the other. Advertisements seeking tenants appeared in the local newspapers beginning in 1955 (Figure 2.44). Beginning in 1957, in addition to operating his store and apartment rental business, Bill Meadows served as a volunteer weather observer, taking readings at his store property to "help local farmers and...provide the nation with valuable permanent weather records" (*Asheville Citizen-Times* 26 January 1982:26; *Asheville Citizen-Times* 5 October 2001:16). In the early 1960s, Bill and Grace Meadows built a new house in the southern portion of their 8.8-acre property, just south of the Meadow's Store and Apartments (BN6343) and moved out of the apartment attached to the store and into the new house (Personal interview, Ben Foster, 22 September 2021). Both structures are visible on a 1964 aerial photograph (Figure 2.45).

**Figure 2.45. Aerial photograph, 1964, showing Meadow's Store and Apartments (BN6343) and the 1960s Meadows family house (United States Air Force 1964).**
